TITLE: Rehabilitation of TCE-Contaminated Underground Storm Water System Using Trenchless Technology

REHABILITATION OF TCE-CONTAMINATED UNDERGROUND STORM WATER SYSTEM USING TRENCHLESS TECHNOLOGY

Michael A. Turco, P.E., DEE and Eric E. Huss
Brown & Root Environmental
993 Old Eagle School Road, Ste. 415
Wayne, PA 19087-1710
(610) 971-0900
(610) 971-9715 telefax
bbrf716@barms061.b-r.com

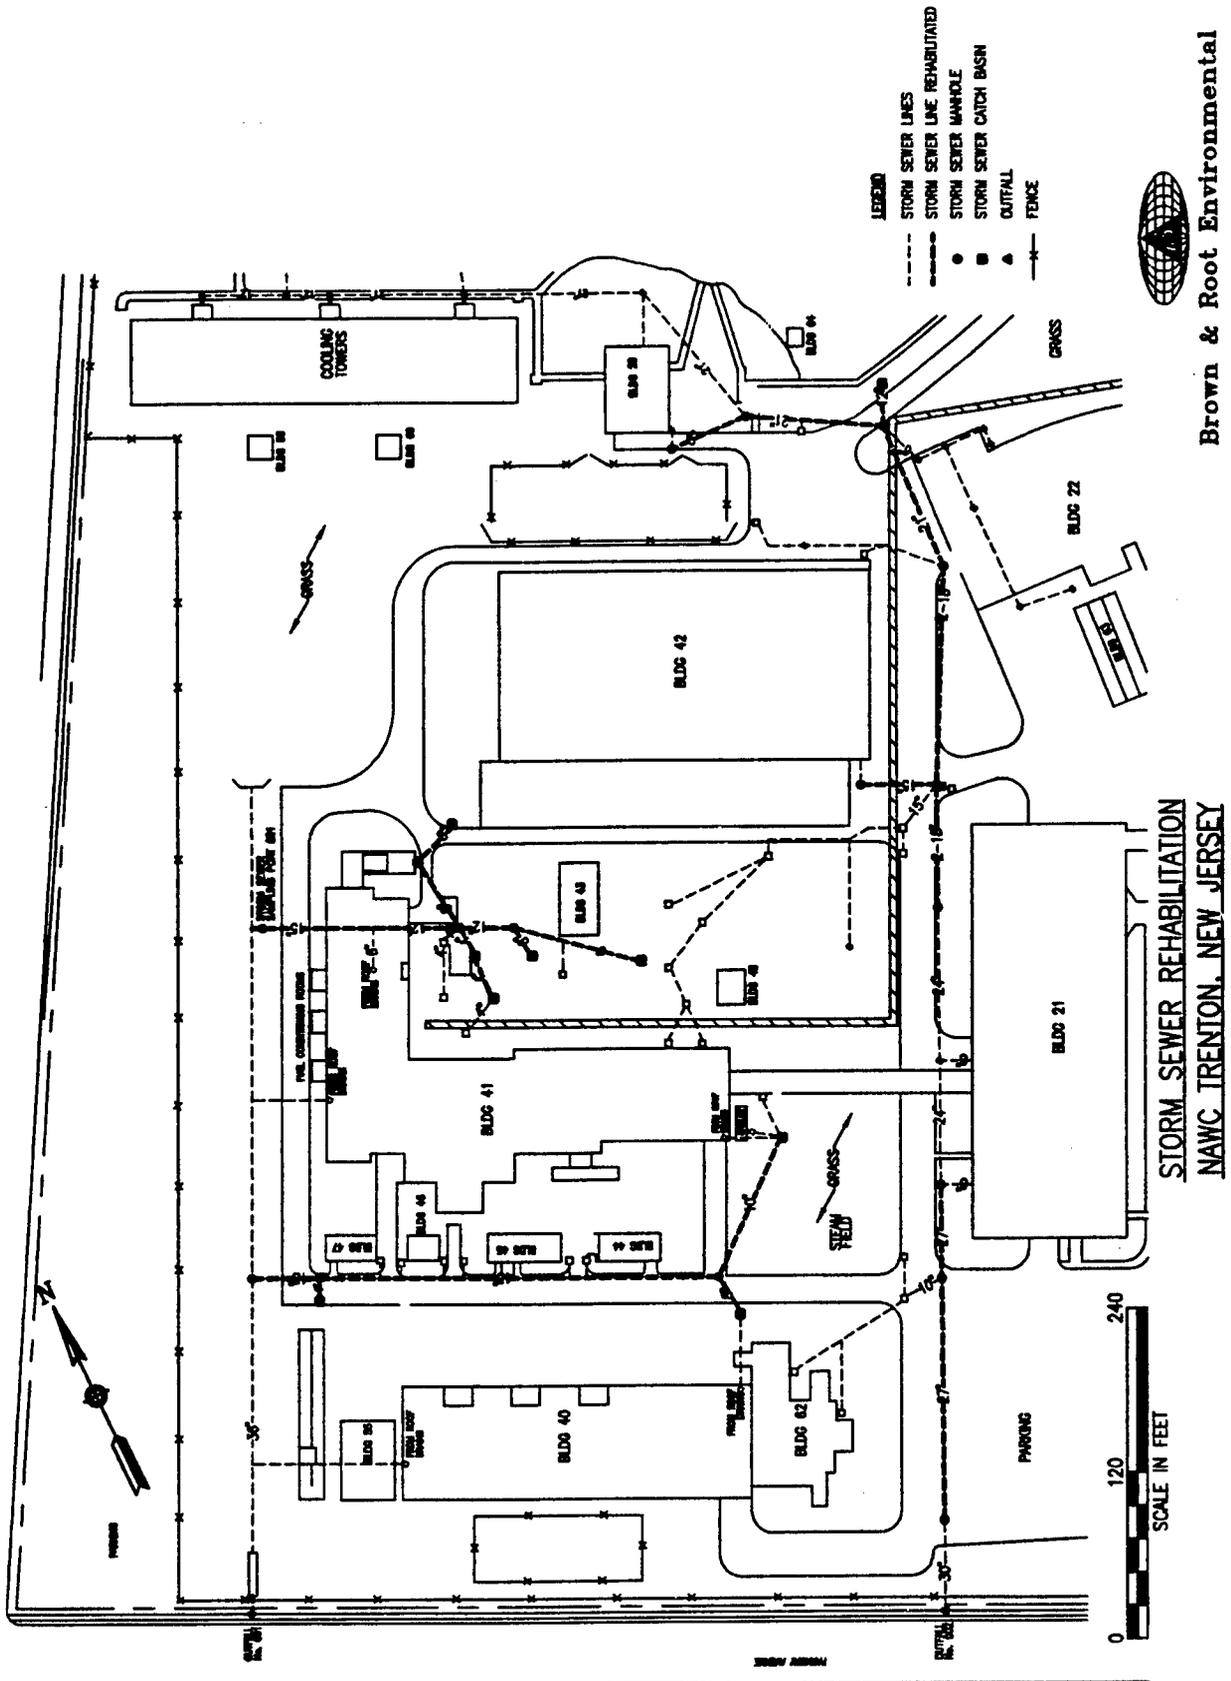
Figure 1. Site Plan of Outfalls 001 and 002 Storm Drainage Area - NAWC Trenton. Heavy dashed lines indicate sewer lines rehabilitated by CIPP technology.
