TITLE: Rehabilitation of TCE-Contaminated Underground Storm Water System Using Trenchless Technology

REHABILITATION OF TCE-CONTAMINATED UNDERGROUND STORM WATER SYSTEM USING TRENCHLESS TECHNOLOGY

Michael A. Turco, P.E., DEE and Eric E. Huss
Brown & Root Environmental
993 Old Eagle School Road, Ste. 415
Wayne, PA 19087-1710
(610) 971-0900
(610) 971-9715 telefax
bbrf716@barms061.b-r.com

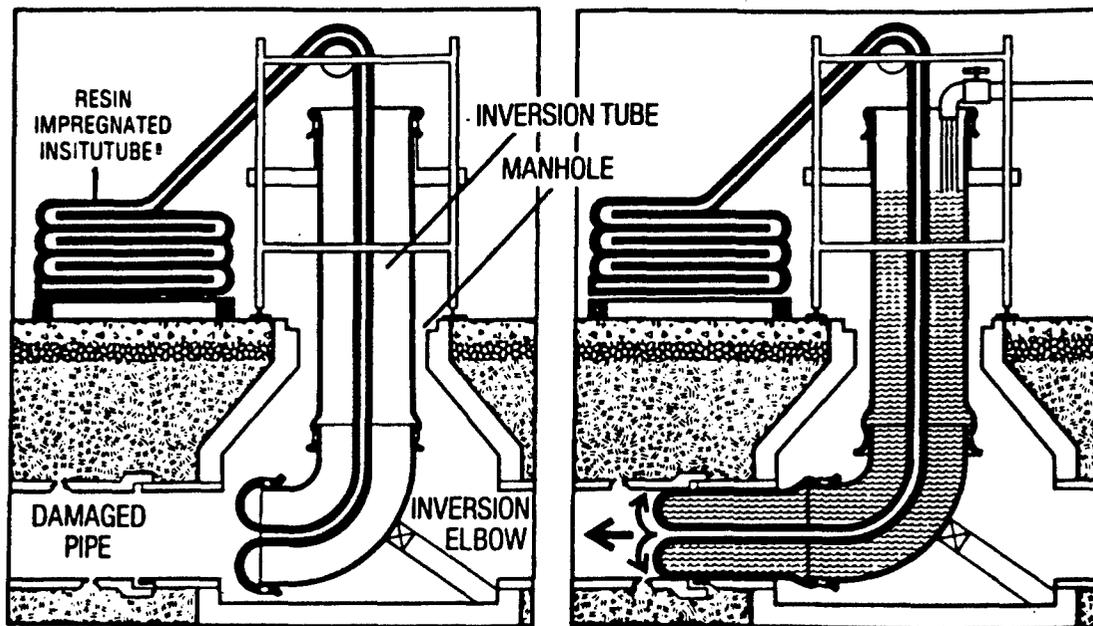
Figure 2. Set Up and Placement of Insituform[®] CIPP

The CIPP technology selected for the NAWC Trenton storm water system rehabilitation was provided by Insituform[®] of North America. The set up and installation is depicted in Figures 2 and 3. A plastic-coated, needled felt tube is custom engineered and prefabricated to the desired length and diameter that is required to fit the deteriorated line(s). It is impregnated with a liquid thermosetting resin and shipped to the installation site. A support scaffold with an inversion tube and elbow is set up over a manway leading to the damaged pipe. One end of the prefabricated tube is banded to the lower end of the inversion tube elbow. The inversion tube is then filled with water. The weight of the water inverts the felt tube and forces it to expand inside the damaged pipe. The tube turns inside out and is pressed by the water against the inside walls of the old pipe. The smooth, coated side of the felt tube becomes the new interior surface of the pipe. (Figure 2).

The inversion process results in no relative movement between the felt tube and the old pipe, minimizing damage to the flexible tube material. Also, any incoming or standing water is forced ahead of the inverting tube and out of the pipe. No water that could inhibit proper curing of the resin or alter the shape of the finished pipe is trapped behind the new tube.

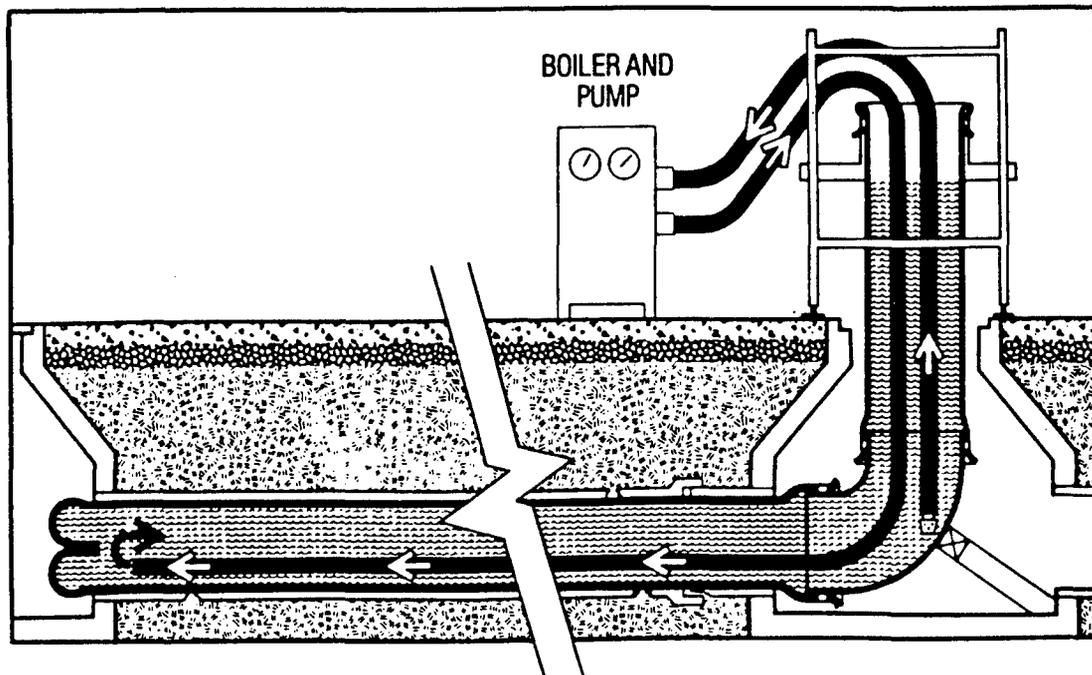
Figure 3. Curing of Insituform® CIPP

After the tube is fully inverted through the old pipe, the water used for inversion is circulated (via a hose attached to and drawn into the tube while it is inverting) through a heater to a temperature of approximately 160° F. The hot water causes the thermosetting resin to cure within a few hours. This changes the the pliable felt tube into a hard pipe-within-a-pipe. (Figure 3). The latter has no joints or seams and should be as strong or stronger than the pipe it replaces. The ends of the hardened pipe are cut off and sealed. The inversion tube and scaffolding are removed. Lateral connections to the pipe are restored by a camera-equipped, remotely controlled cutting device.
